**Second
Evaluation
of
406 MHz
Location Protocol
Distress Beacons**

November 11, 2005

Principal Author: Douglas S. Ritter

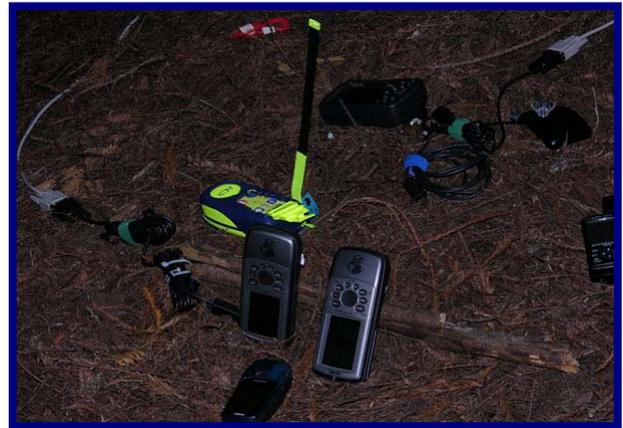
1. One ACR AquaFix / PLB, Model PLB201, the model without an integral GPS, was included in the test beacons received from West Marine. Both the box for the beacon and the beacon itself was correctly marked, though this marking is only a checkmark in a box on a side panel and a small sticker on the end panel. Otherwise the box is identical for both beacons. We have been unable to ascertain how this beacon came to be sent for the testing from the store involved or why it was not identified as incorrect at the time of receipt, but on the sheet provided by West Marine of the test beacons received it was incorrectly identified as a Model 200. Subsequently, at no time during the test protocol assignment by

ACR Model PLB201 without GPS showing light colored faceplate

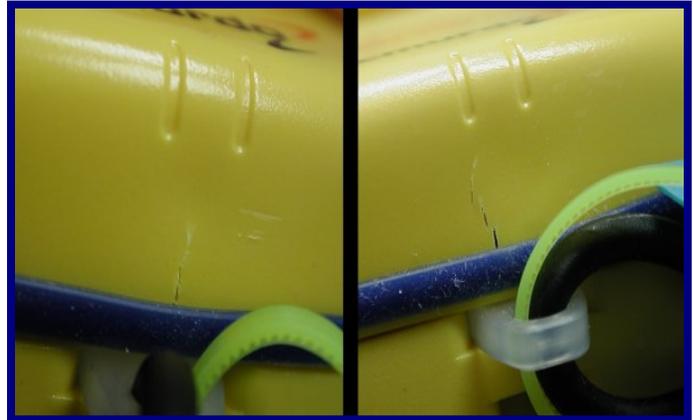
2. During the test protocol assignment process, it was observed that three McMurdo Fastfind Plus PLBs appeared to have cracks in the case where the battery retention screw is located. It was determined at that time to avoid assigning these beacons to those few maritime tests where the beacon would be subject to immersion and the crack may have allowed water penetration, resulting in a failure. We had no way of determining if it would or wouldn't at the time. Since the primary purpose of the evaluation was to test the GPS function, this was determined to have been

Cracked cases of two McMurdo Fastfind Plus PLBs

It is not clear how the plastic came to be cracked on these two units in this area, but the assumption is that it is due to over tightening of the battery retaining screw in the insert that goes into this boss. McMurdo set limits for the torque on this screw and provides details both in its assembly process and in its battery replacement instructions to consumers about the correct torque to apply to this screw. Copies of both of these documents have already been forwarded to ETSF.

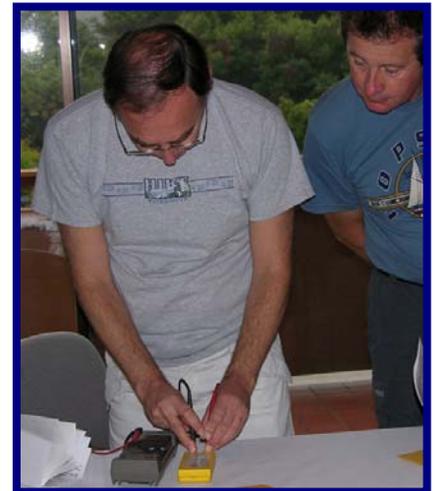
Investigations have shown that there was nothing wrong with the PLB or the Battery Pack that would explain why the battery was discharged (flat). McMurdo has checked its records and can find no evidence of this problem ever having occurred previously. The cells within the battery have been returned to the manufacturer for investigation, however a report back is not expected for sometime and it is considered unlikely at this time that this will reveal any additional facts or information. It is suggested that we try and track the history of this beacon to see if this might provide any indication of how the battery could have got into this condition. Self testing the beacon prior to going on a trip would have shown up this problem and allowed the user to obtain a replacement unit.

Chris Hoffman (McMurdo Director of Engineering) checks dead PLB battery during recoding session

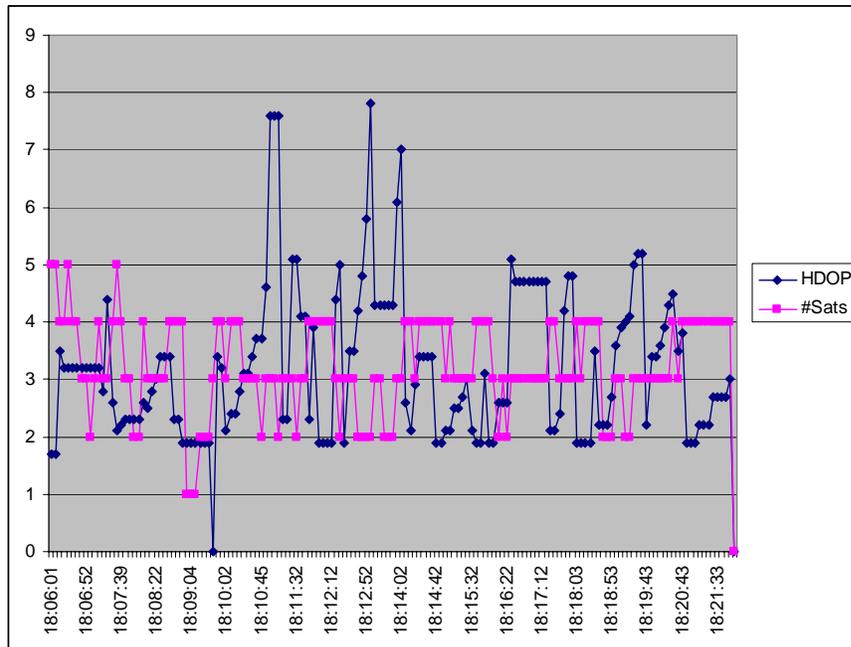
Inland Scenario Charlie - July 14 18:06 – 18:22
ACR Prototype PLB - GPS location at 18:18:40

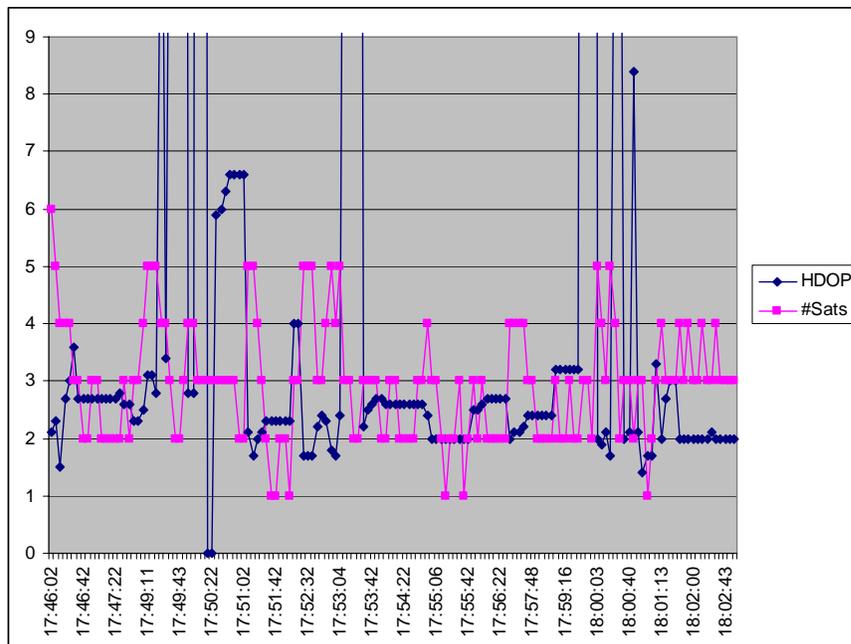
Inland Scenario Charlie - July 14 17:46 – 18:03
McMurdo Fastfind Plus PLB - No GPS location

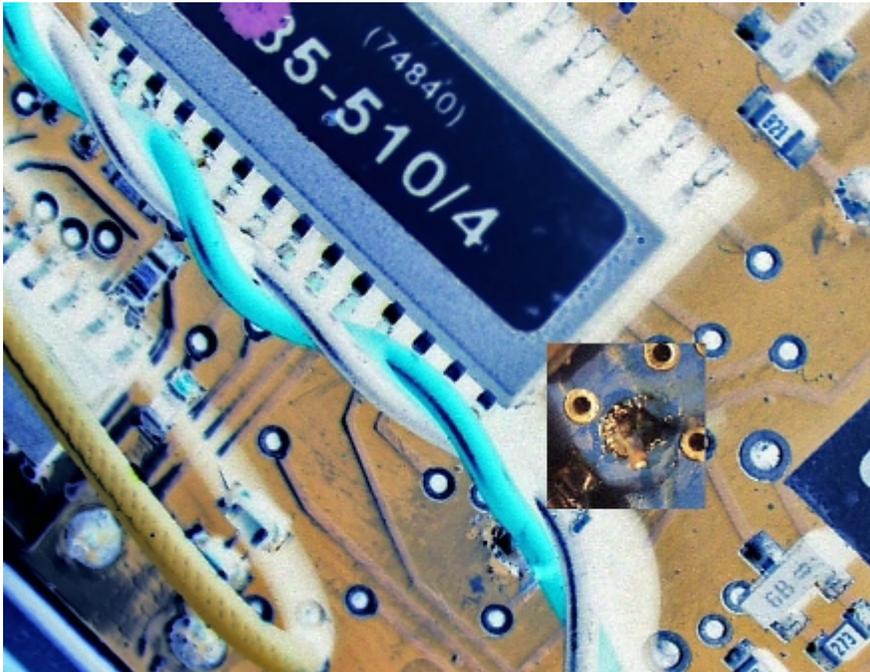
The joint was reflowed and the beacon programming function rechecked. The beacon then programmed successfully.

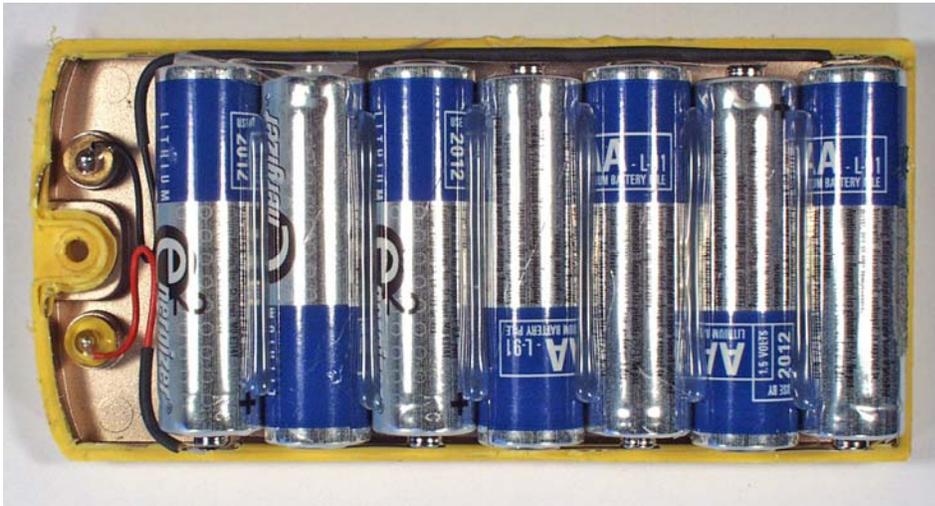
Further examination of the internals of the pack indicated that all wires were in place and all joints were correctly made. There was no evidence of leakage from the battery or swelling of the cells in the battery or any other defect with the cells. Measurement of the individual cell voltages did not indicate that any one cell or a few cells were any more discharged than the rest of the cells.

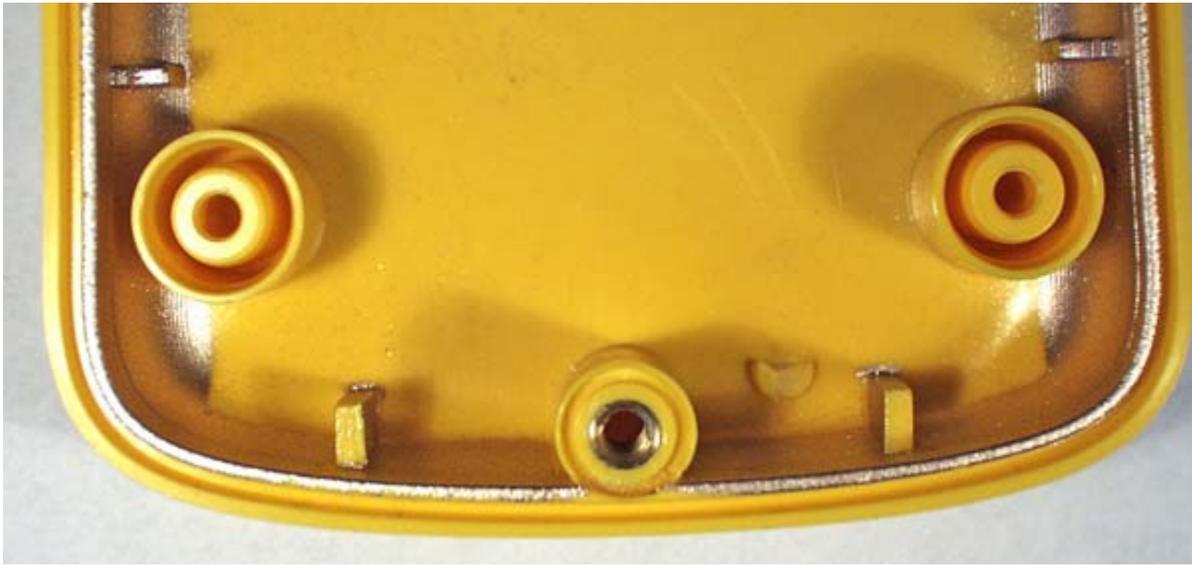
The following photograph shows the internal features of the boss.
