**Second
Evaluation
of
406 MHz
Location Protocol
Distress Beacons**

November 11, 2005

Principal Author: Douglas S. Ritter

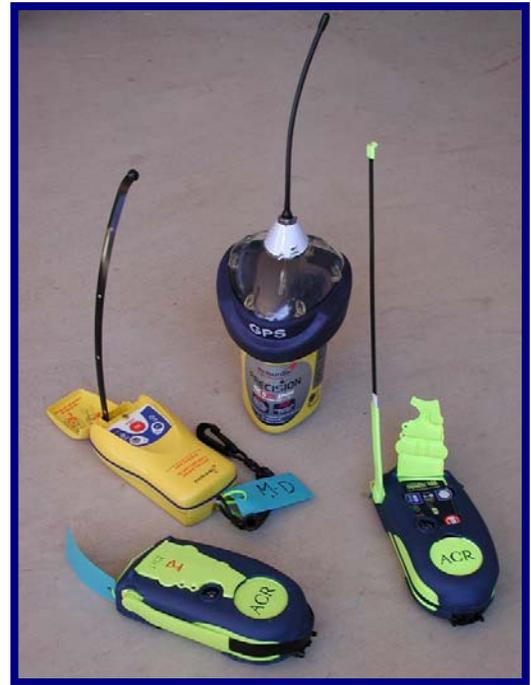
Location Protocol 406 MHz Emergency Beacons tested: (clockwise from 12:00) McMurdo Precision EPIRB, ACR AquaFix PLB-200, ACR Prototype PLB, McMurdo Fastfind Plus PLB

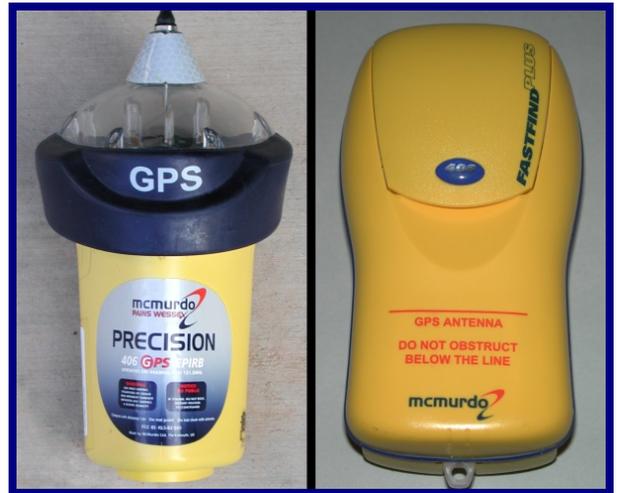
Upgraded McMurdo Location Protocol
Beacons: Precision 406 GPS EPIRB (left),
Fastfind Plus GPS PLB (right)

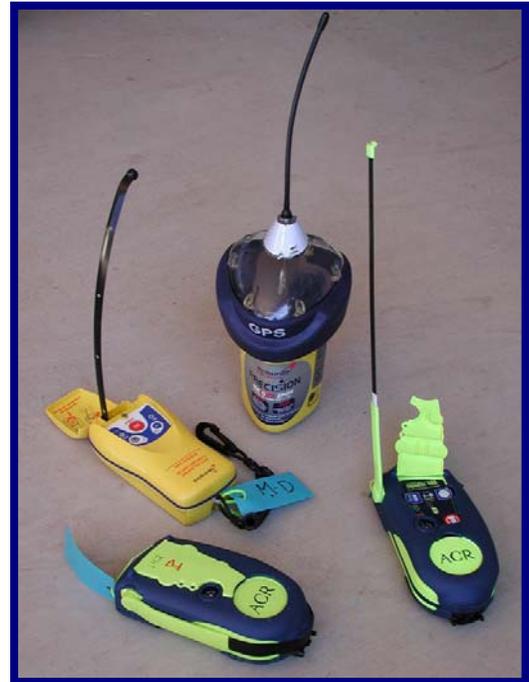
Location Protocol 406 MHz Emergency Beacons tested: (clockwise from 12:00) McMurdo Precision EPIRB, ACR AquaFix PLB-200, ACR Prototype PLB, McMurdo Fastfind Plus PLB

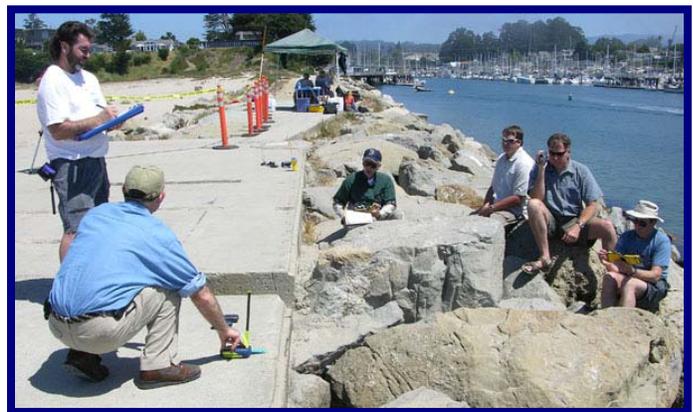
Baseline Scenario Alpha – Doug Ritter preparing to activate ACR PLB-200, manual recording of GPS location and time, WS Technologies BT100A receiver operators on rocks below.

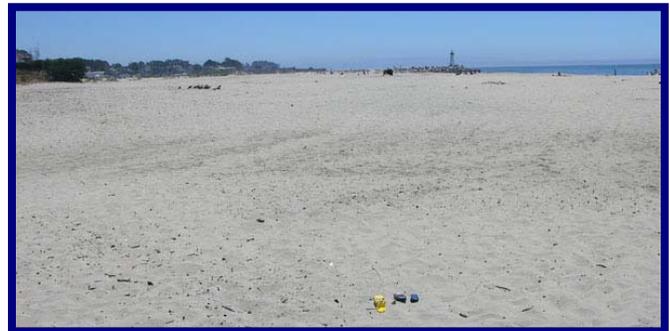
Baseline Scenario Bravo.

Baseline Bravo relocated McMurdo Fastfind Plus PLB looking back towards Baseline Alpha location on jetty

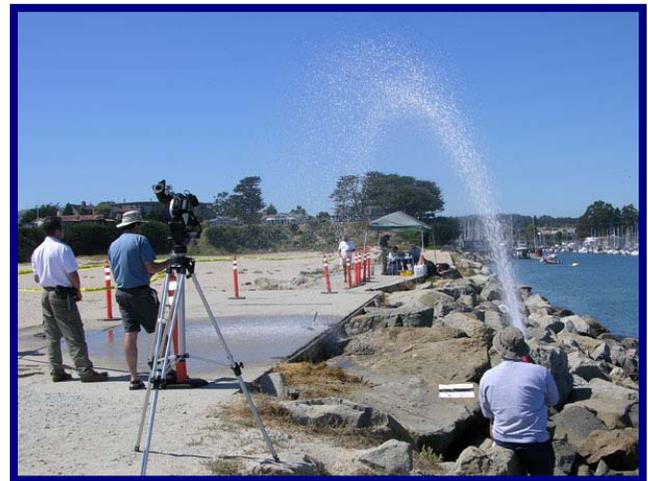
Baseline Scenario Charlie – Simulated rain on ACR Prototype PLB

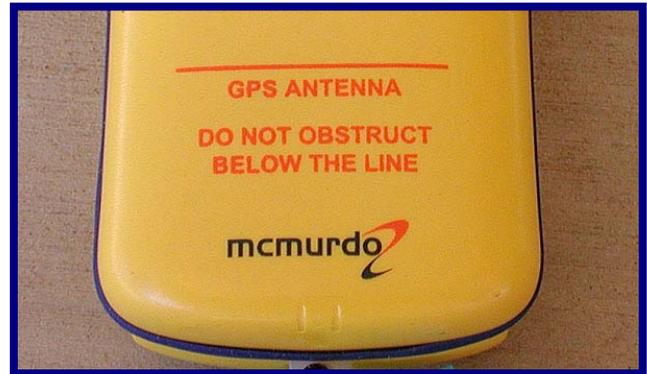
McMurdo Fastfind Plus PLB GPS antenna
identification and warning

10. Operating instructions on or attached to the beacon should emphasize the importance of GPS antenna orientation when this is an inherent design factor for optimum performance, the importance of not blocking the antenna with the body or body parts, and for marine operations, the importance of keeping the GPS antenna clear of the water if possible. The location and preferred orientation of the GPS antenna should be clearly marked. In instances where the GPS antenna might likely be covered by a survivor's hand(s) while being held in a foreseeable manner or by foreseeable means

of securing the beacon to a person or object under foreseeable survival circumstances, a warning against doing so should be clearly displayed. McMurdo has provided a practical and effective integration of some of these suggestions in their upgraded Fastfind Plus PLB.

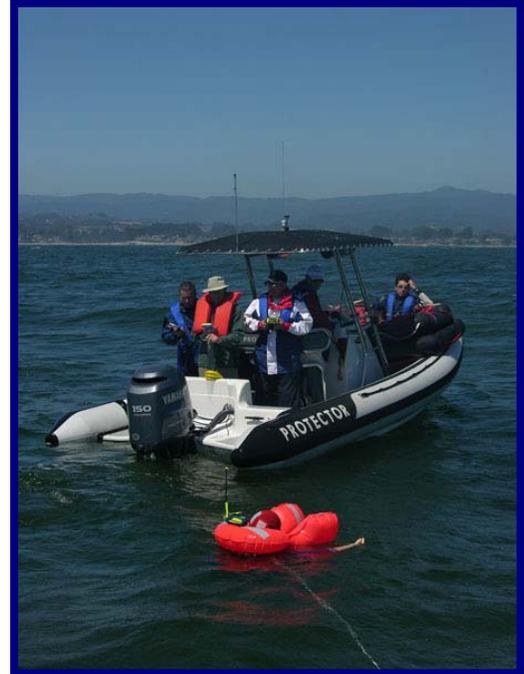
Maritime Scenario Golf – ACR
Prototype PLB attached to PFD on
Oscar with BT-100A test receivers in
RIB.

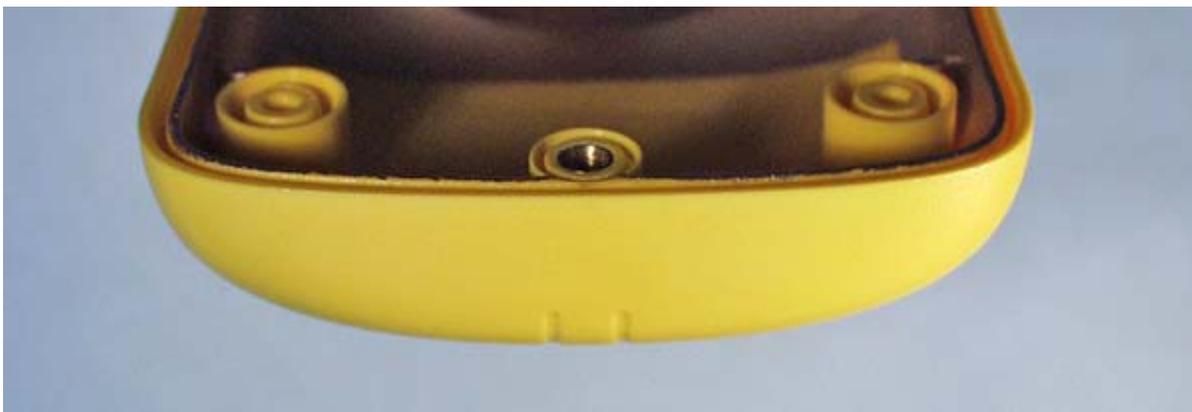
While examining the beacons for use on the trials ETSF discovered two of the 15 Fastfind Plus PLBs that they had showed evidence of a small crack in the upper surface of the plastic body near the lanyard retainer / battery retaining screw. One of these units (Trials ID 111614) was returned to McMurdo's facilities in Portsmouth UK for further investigation.

The small very fine crack is in the upper surface of the PLB body above the boss in the plastic that is used to retain the battery pack, between the two fine indentations in the upper surface of the plastic, see photograph below.
